3737 Sharp Road Private

Inventory No. HO-1014

Maryland Historical Trust Maryland Inventory of Historic Properties Form

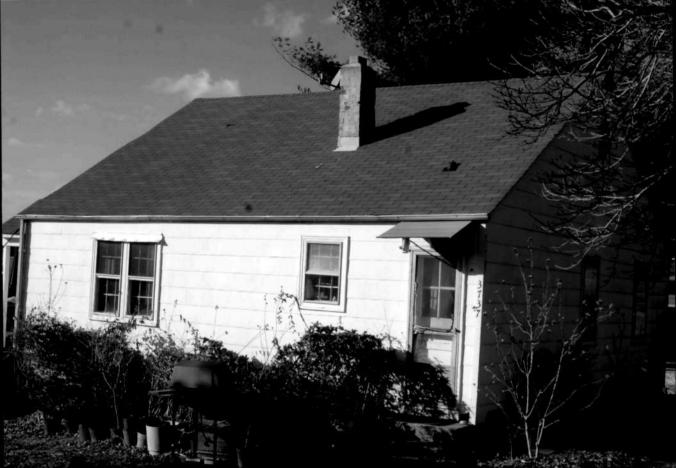
HO-1014_2010-01-27_01 South & east elevations

- A 40-1014 3737 Sharp Road Howard County, MD Ken Short Jan 27, 2010 MD SHPO South & East Elevations

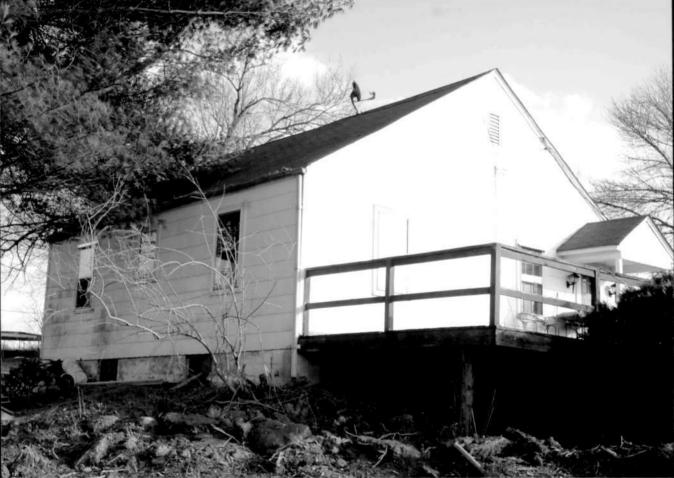
HO-1014_2010-01-27_02 North & west elevations

41111 HO-1014 3737 Sharp Road Howard County, MD Ken Short Jan. 27, 2010 MDSHPO North & West Elevationis 2/2
